**OU1 Design Change and Modification Sheet:
Change/Modification # 40**

Property ID: _____ Operable Unit 1, Area 1

Design Change / Modification Description:

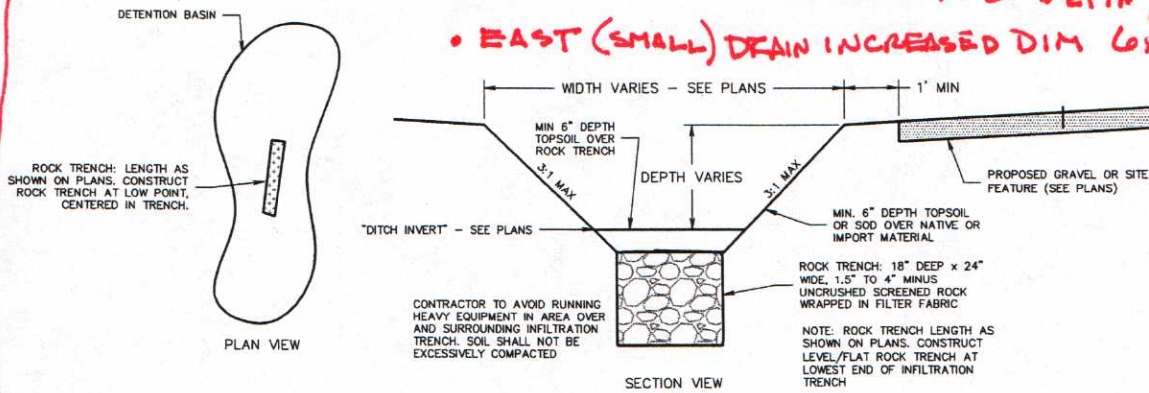
PORTION OF SHIT C6A

APPROX. AREA OF
FLOODING

ROCK DRAINS

20 LF ROCK TRENCH
DITCH INV 64.25

10 LF ROCK TRENCH
DITCH INV 65.00

- WEST (LARGE) DRAIN INCREASED DIM. 14' x 20' x 8' DEPTH
- EAST (SMALL) DRAIN INCREASED DIM 6' x 10' x 6' DEPTH

Reference Sheet C6A, Titled OU1-Remedial Action, Proposed Final Grading and Restoration Plan (Search and Rescue Area). As the result of unseasonably heavy rains the drainage system was overwhelmed and a portion of the new City Services Road flooded. The portion of the road which flooded is by design the low point in the road. There are two rock trench drains in this area. One on either side of the roadway. Both of the drains were built as designed (see attached detail sheet) but failed to be capable of handling the volume of water which resulted from the event, thereby allowing the road to flood. On July 17, 2012, the City of Libby formally requested help from the EPA to correct the issue. A determination was made that the drains had to be significantly deepened to facilitate a greater volume of water. The west drain was dug to a depth of approximately 8' at which point ground water was encountered. The width of the drain was increased to a width of approximately 14', with the length remaining at the design length of 20'. The smaller drain on the east side of the road was excavated to a depth of 6' and to width of approximately 5', the length remained as designed at 10'. The small drain's close proximity to the roadway prohibited further widening or deepening of the excavation. A marker barrier was installed as prescribed. The excavation(s) back filled with a combination of 3-6" rock with a 1 1/2" washed rock cap. Filter fabric was installed to prevent premature sedimentary clogging of the drain, and the rock inlet was ringed with straw wattle as a sedimentary barrier. Additionally a broad swell was created as an overflow from the west drainage structure to the adjacent property to the west as approved by the City of Libby.

See attached drawing(s) for location of drains/flooding and the designed rock trench detail.

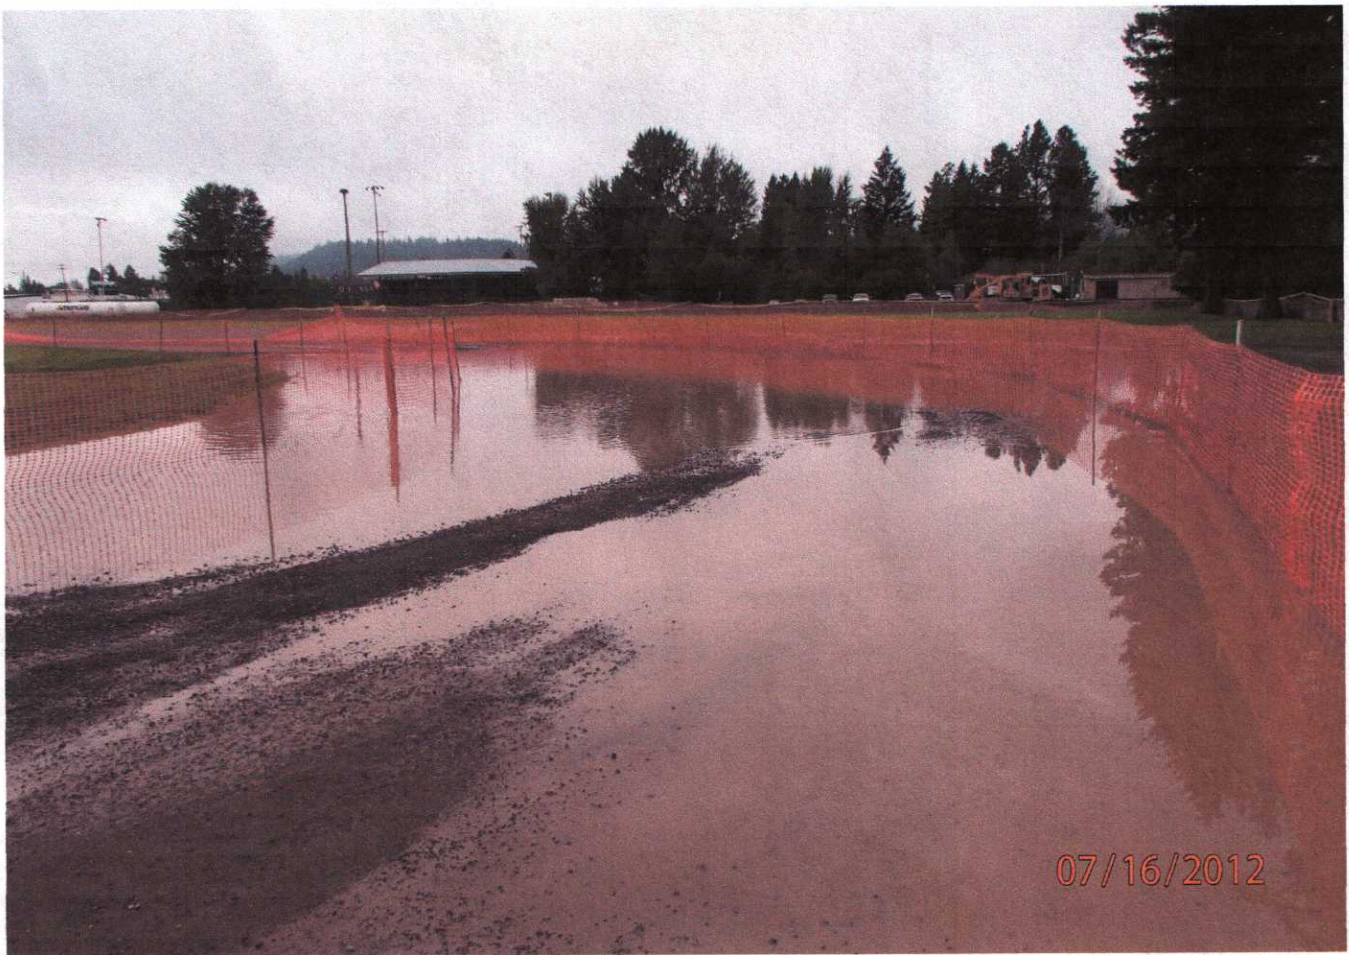
1) VIEW OF THE FLOODED PORTION OF CITY SERVICES ROAD

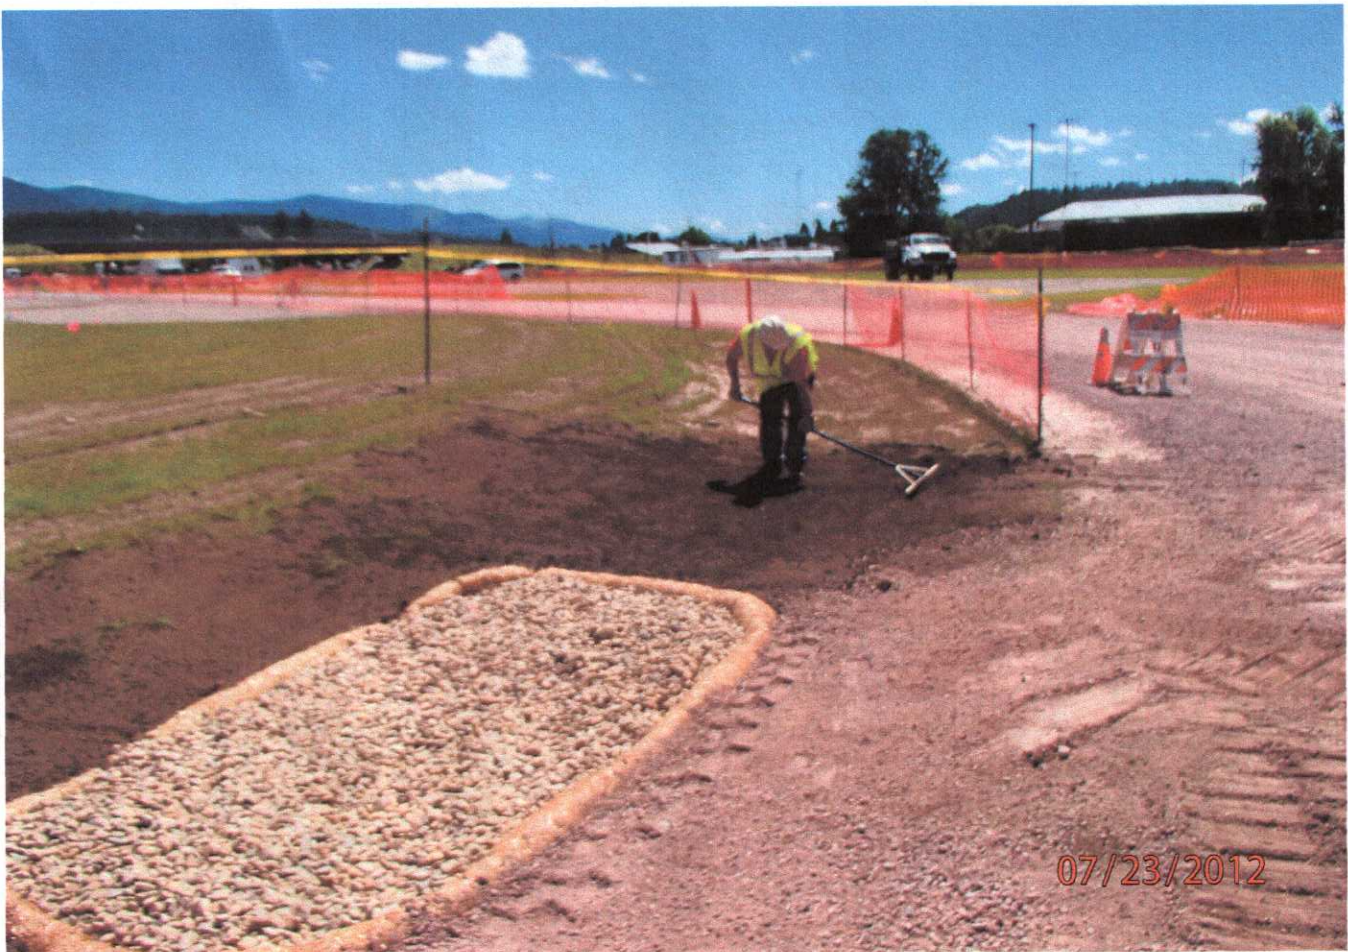
2) COMPLETION OF SMALL/EAST DRAINAGE STRUCTURE

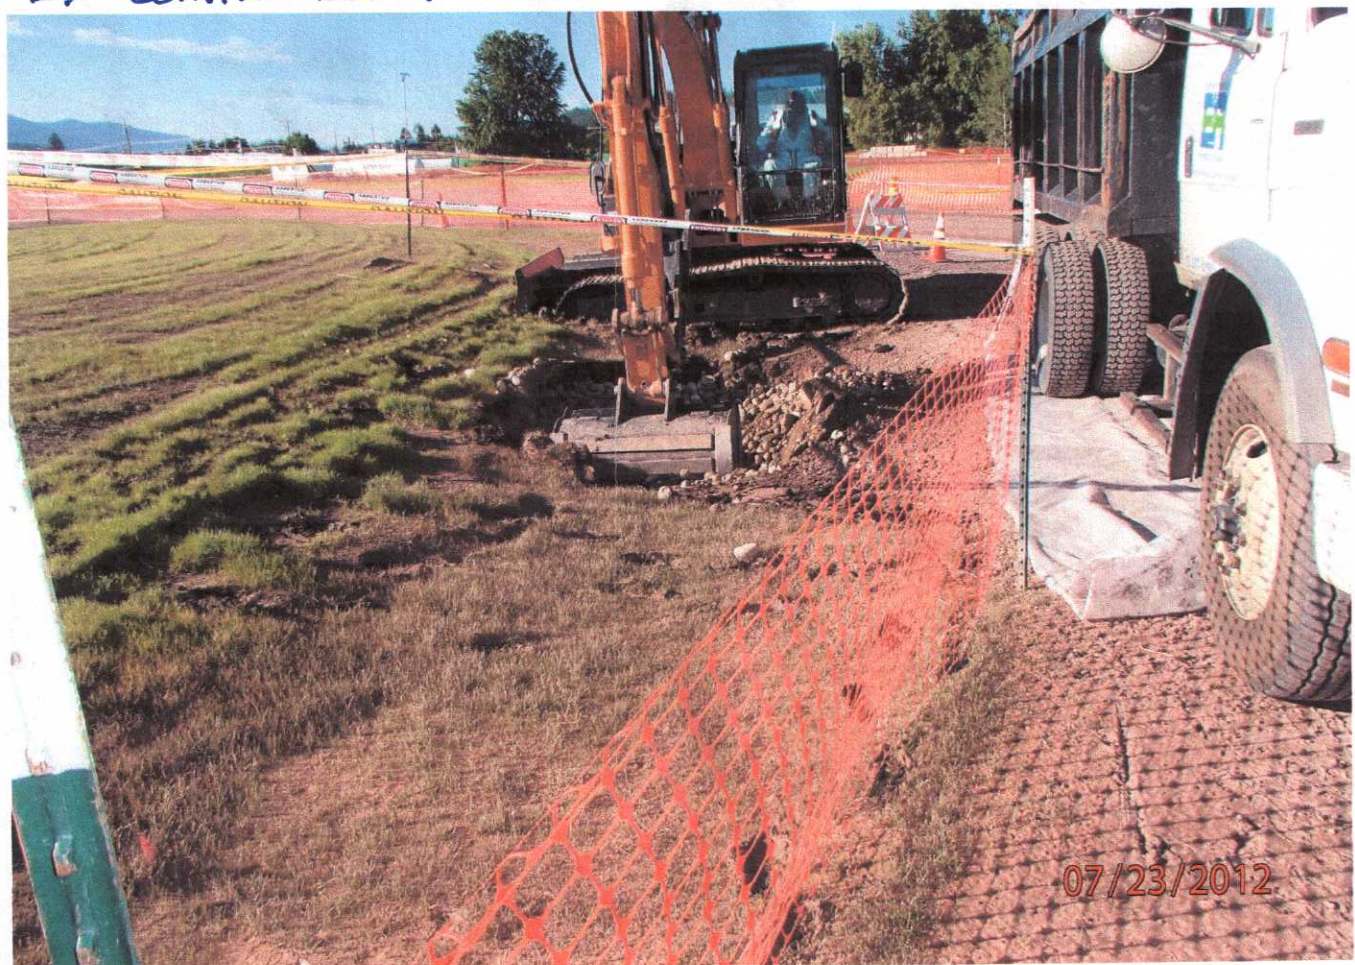
3) ENLARGEMENT OF SMALL/EAST DRAINAGE STRUCTURE

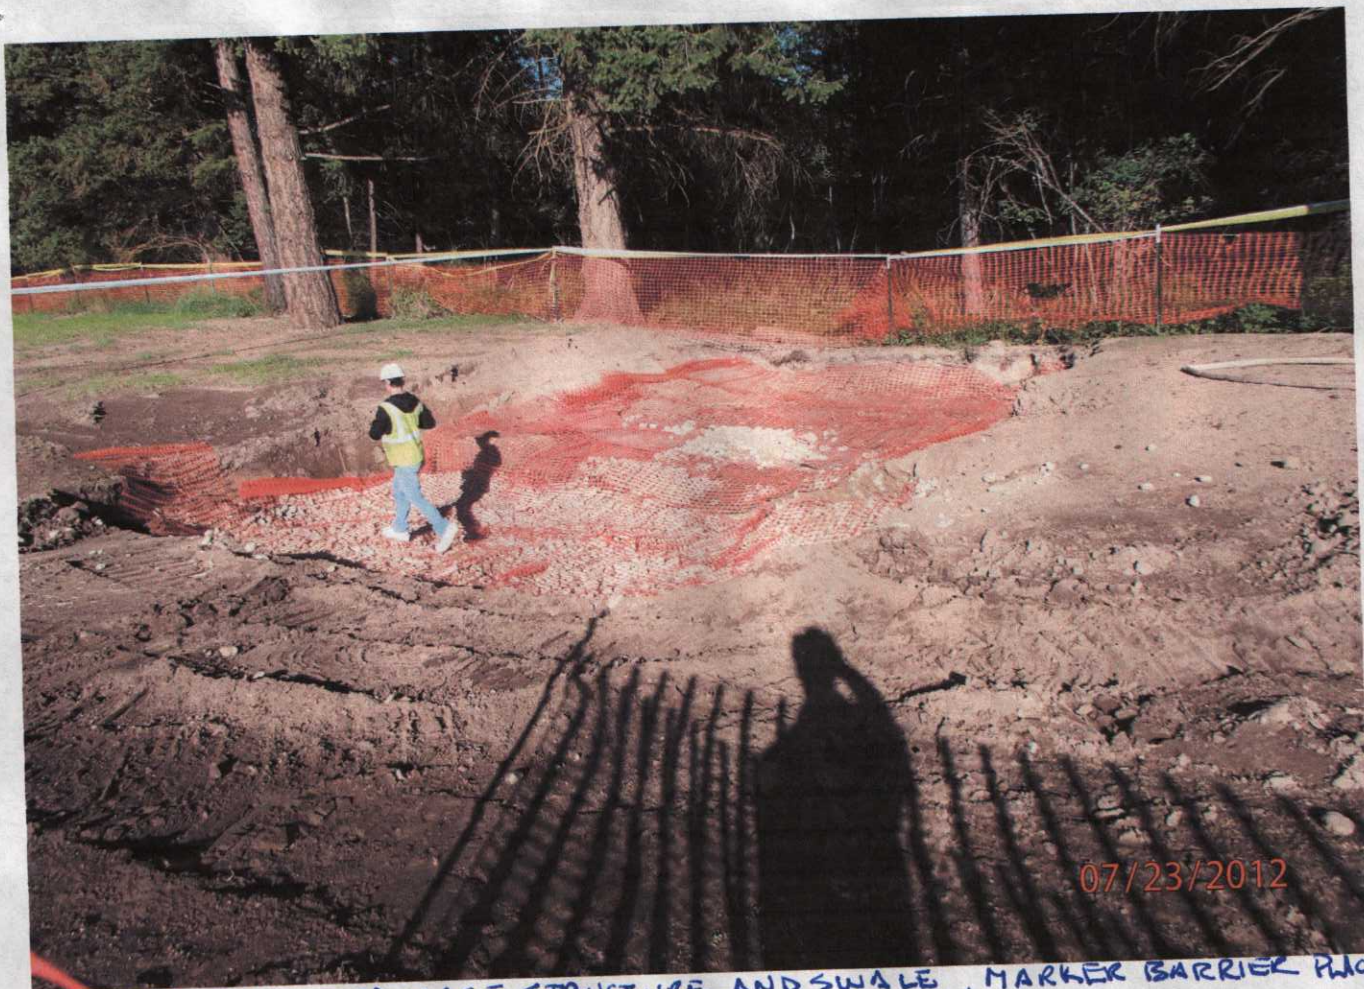
4) LARGE / WEST DRAINAGE STRUCTURE AND SWALE , MARKER BARRIER PLACEMENT

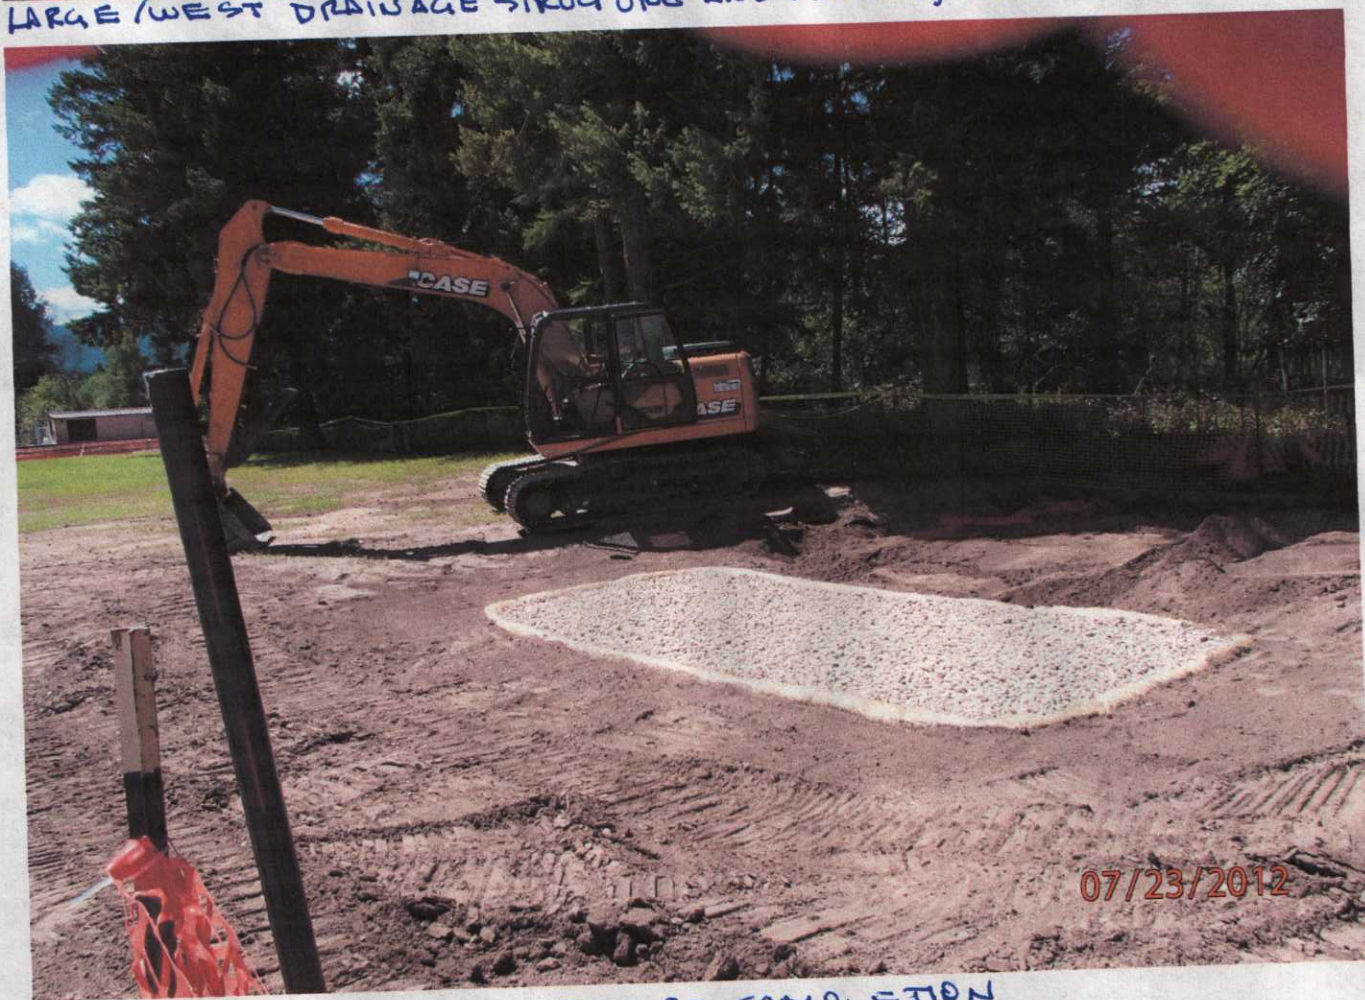
5) LARGE / WEST DRAINAGE STRUCTURE COMPLETION
